Newington Town Hall
Renovation Feasibility Study
Newington, CT

April 20, 2016

Feasibility Study

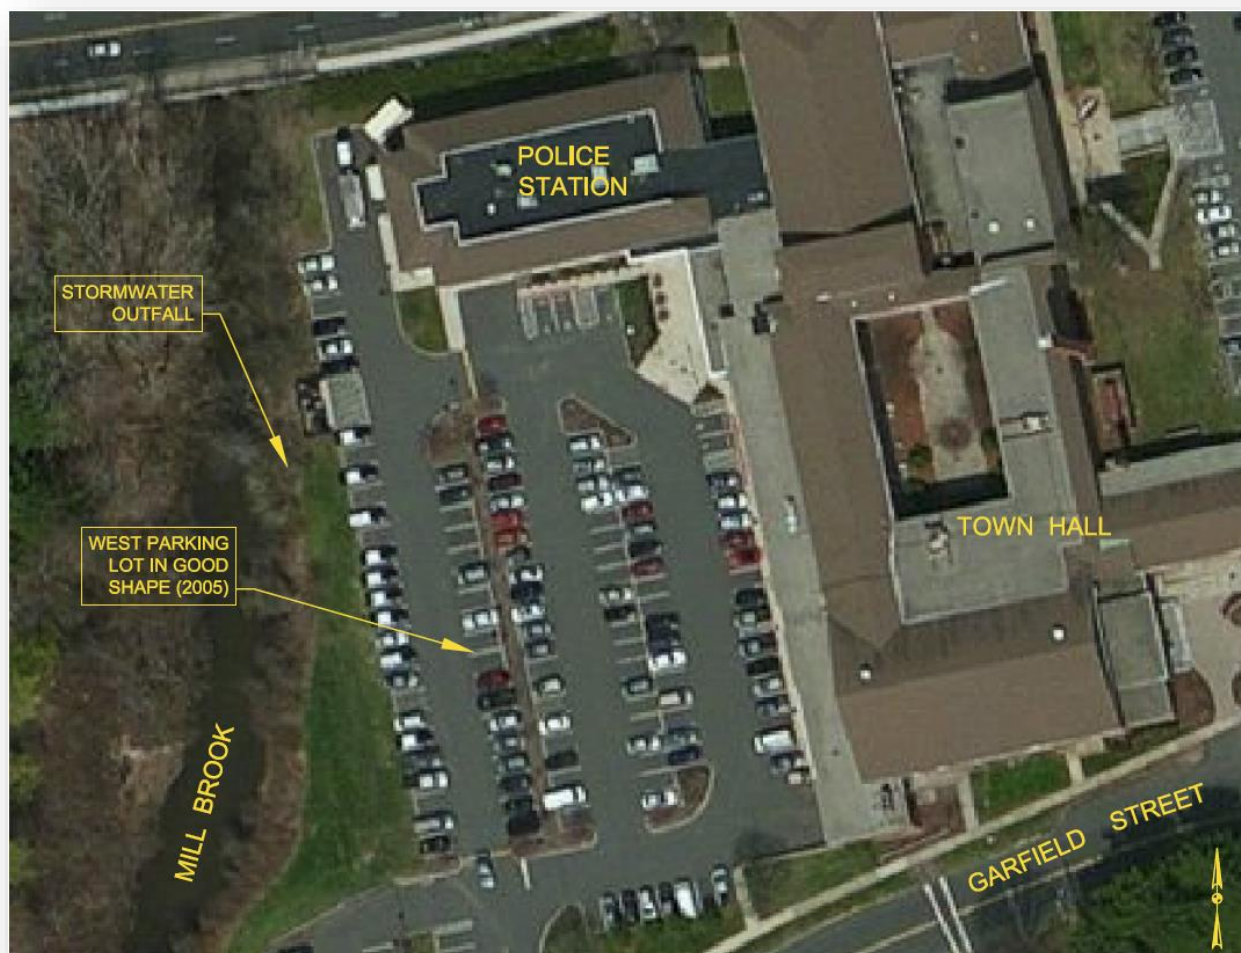
3.8.1 Western Parking Lot

The walkways and parking area on the west side were reconstructed when the Police facility addition (2005) was completed, and they are in excellent condition. Travel for pedestrians on the west side is good.

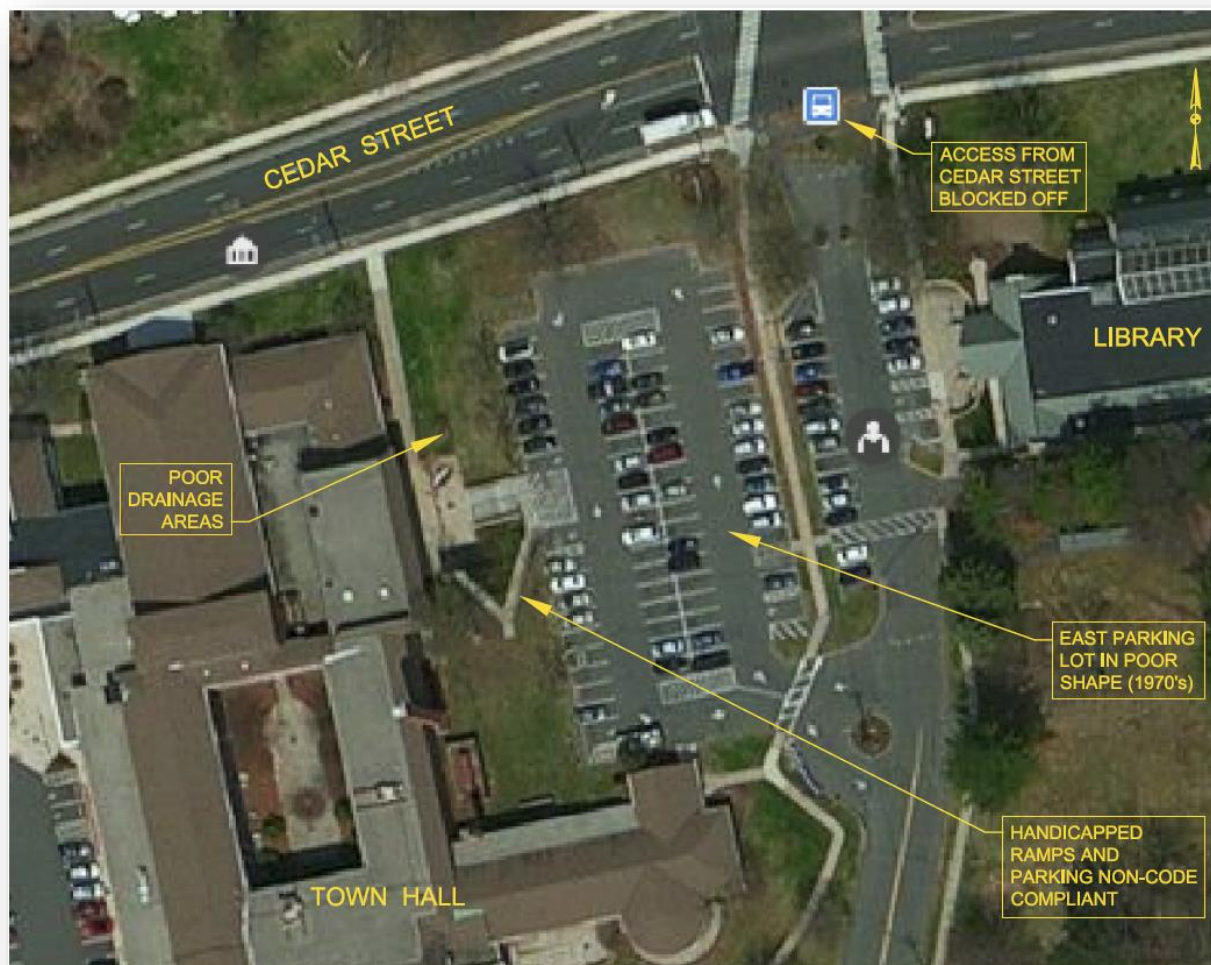
3.8.2 Eastern Parking Lot

The eastern parking lot dates to the 1970 construction and is in poor shape and should be reconstructed.

Travel for pedestrians is poor from the eastern lot with a set of stairs that are in extremely poor condition and a bituminous concrete ramp/walk that is also in relatively poor condition.

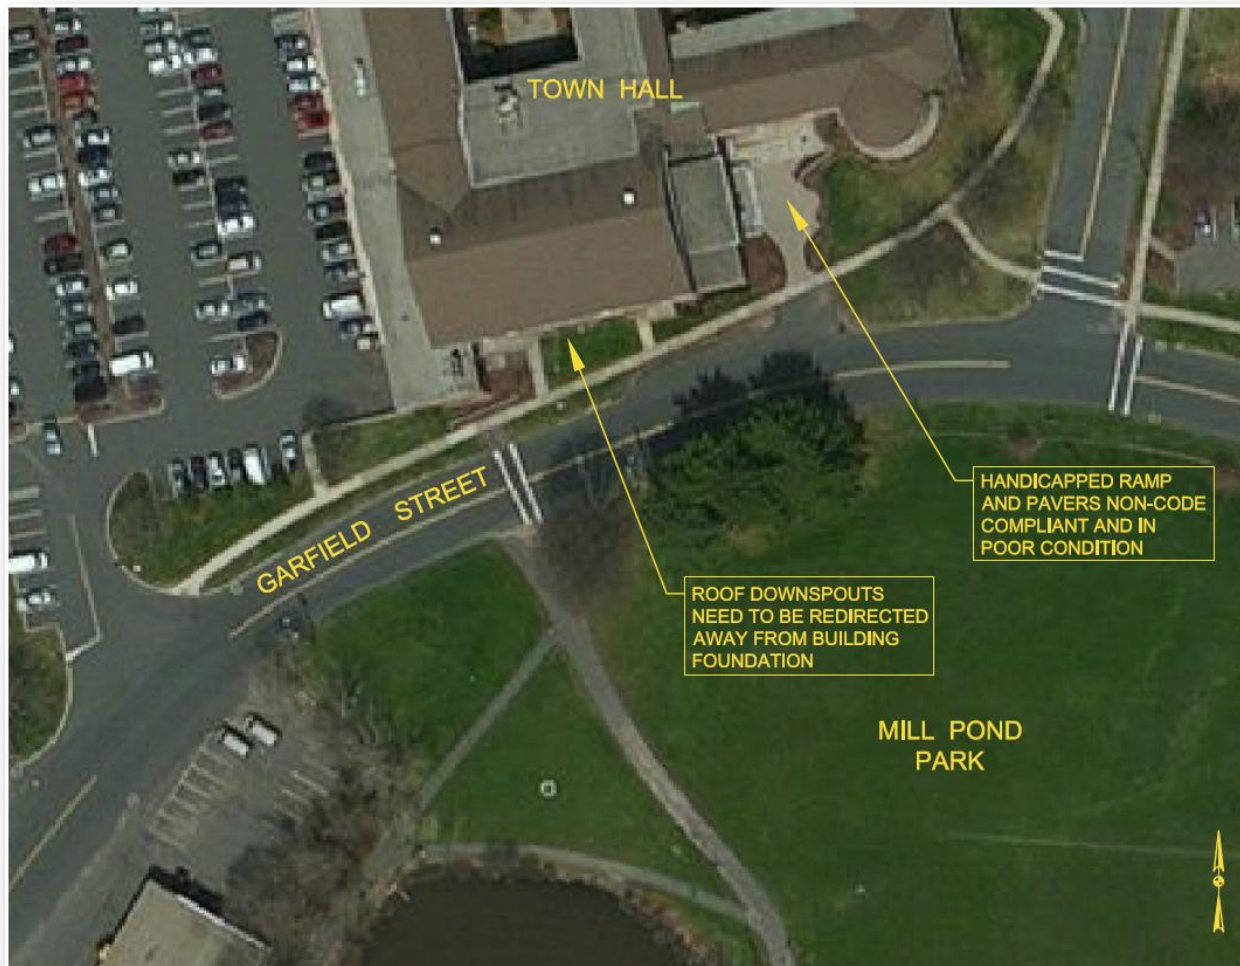
3.8.3 Southern/Garfield Street

Handicapped ramps on the south are poor and do not meet current standards. Downspouts do not appear to provide adequate drainage away from the building and runoff may be contributing to water issues in the building.

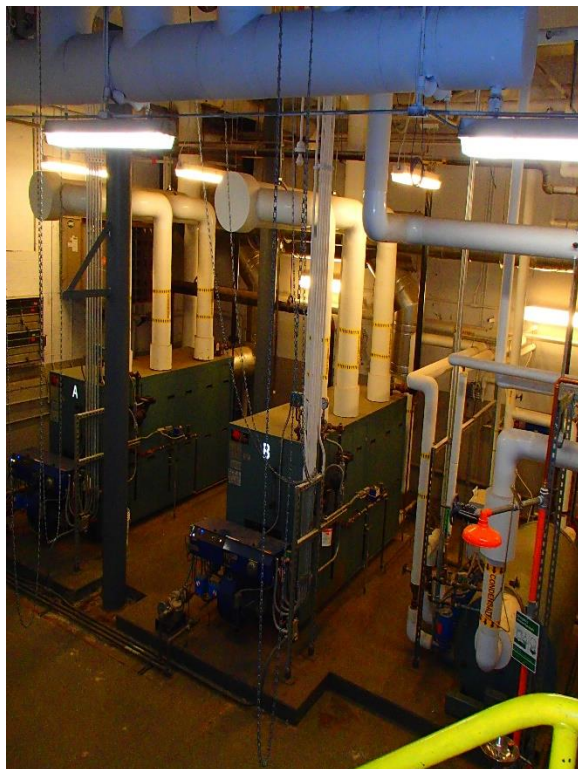
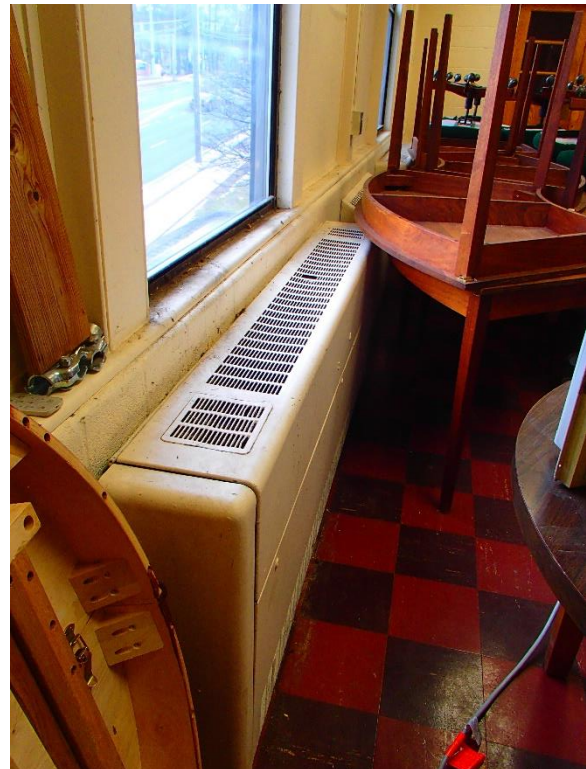
The heating plant includes two Smith Model 28HE-14 dual-fuel cast iron steam boilers that were installed in 2008, and are currently in good condition. They each have a Net IBR output capacity of 2,769 MBH which equates to approximately 75% of the building's peak heating load, resulting in redundancy should one boiler require maintenance or repair. While these boilers are in good condition, the steam and condensate distribution piping is in very poor condition with leaks throughout the facility. Much of this piping dates back to the original construction of the building in 1950, and is currently in need of replacement. The steam systems feeds various air-handling units, fan-coil units, unit ventilators, convectors, and radiators. Due to the fact that the steam and condensate distribution piping must be replaced fairly soon, it is recommended that either the existing boiler plant be converted to hot water, or new high-efficiency hot water condensing boilers be installed. New boilers would result in significant operational cost savings.

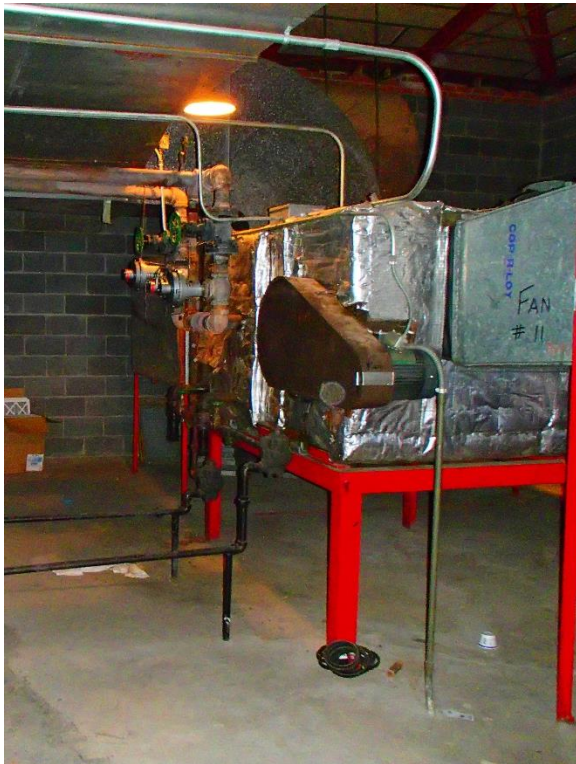
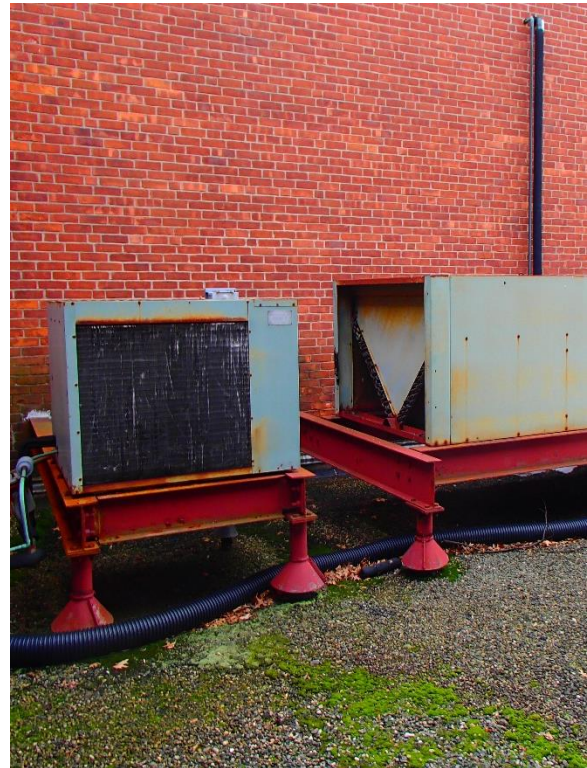
Split system air-handling units with steam heating and direct-expansion cooling serve some areas of the facility, including the Multi-Purpose Space, Town Council Chamber & adjacent offices, and the lobby & adjacent interior spaces. Associated condensing units are located either on the roof or at grade, generally nearby to the air-handling units. This equipment was installed in the 1950's, the 1970's, or the 1980's. Based on the age and appearance of these systems, replacement is recommend.

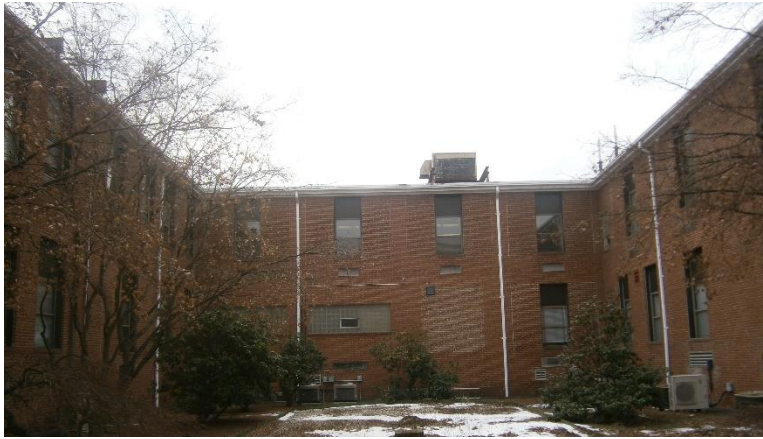
Two packaged rooftop units that were installed in the 1970's serve interior portions of the Second Floor. Based on the age and appearance of these units, replacement is recommend.

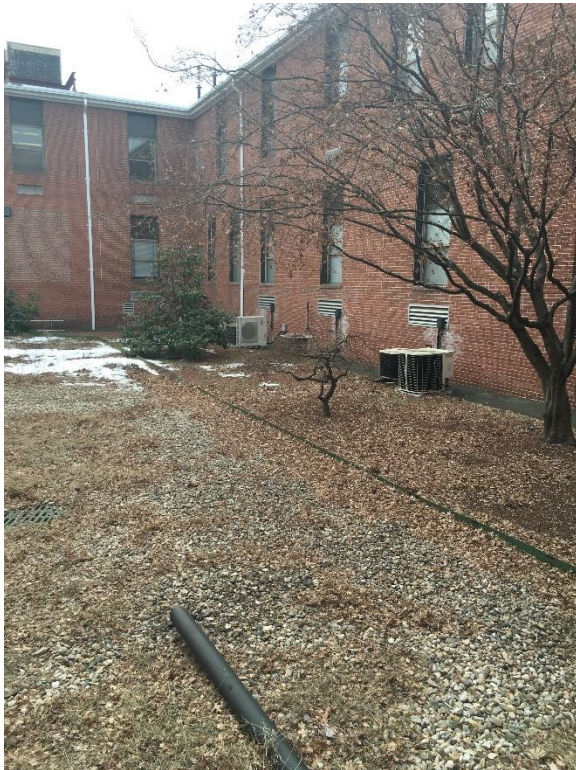
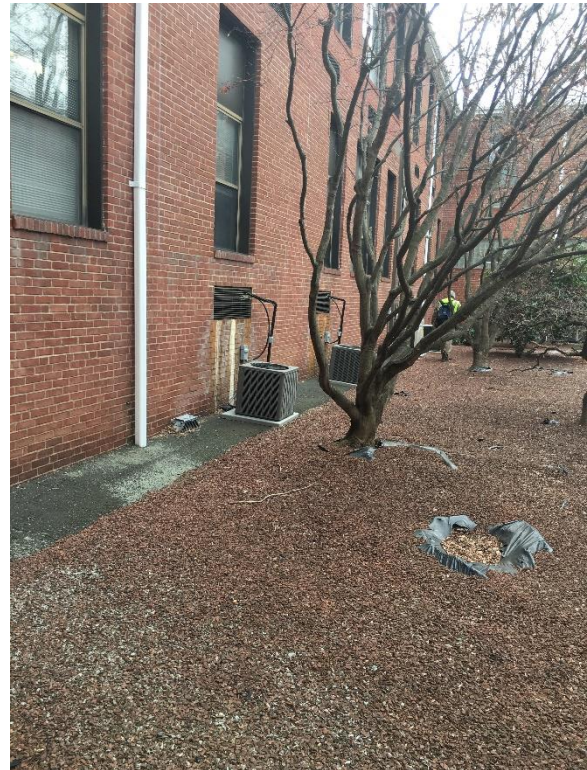
Through-the-wall air conditioning units and unit ventilators installed in the early 1970's serve or previously served many of the office areas throughout the facility. As many of these systems have failed over the years, small independent fan-coil units and split systems have been installed, with the associated condensing units located in the courtyard, on grade outside the building, or on the roof. These numerous independent small split systems are inefficient, do not often provide mechanical ventilation, and the number of systems creates increased maintenance costs.

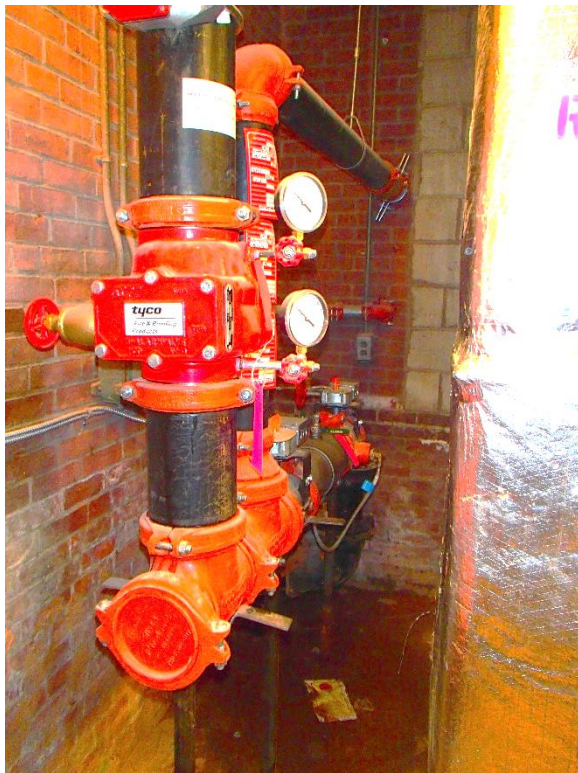
Sprinkler System Riser - Wet System

Two sprinkler services and rooms exist. One is a six-inch wet system and another is a six-inch dry system. A backflow preventer was not located for the dry system.

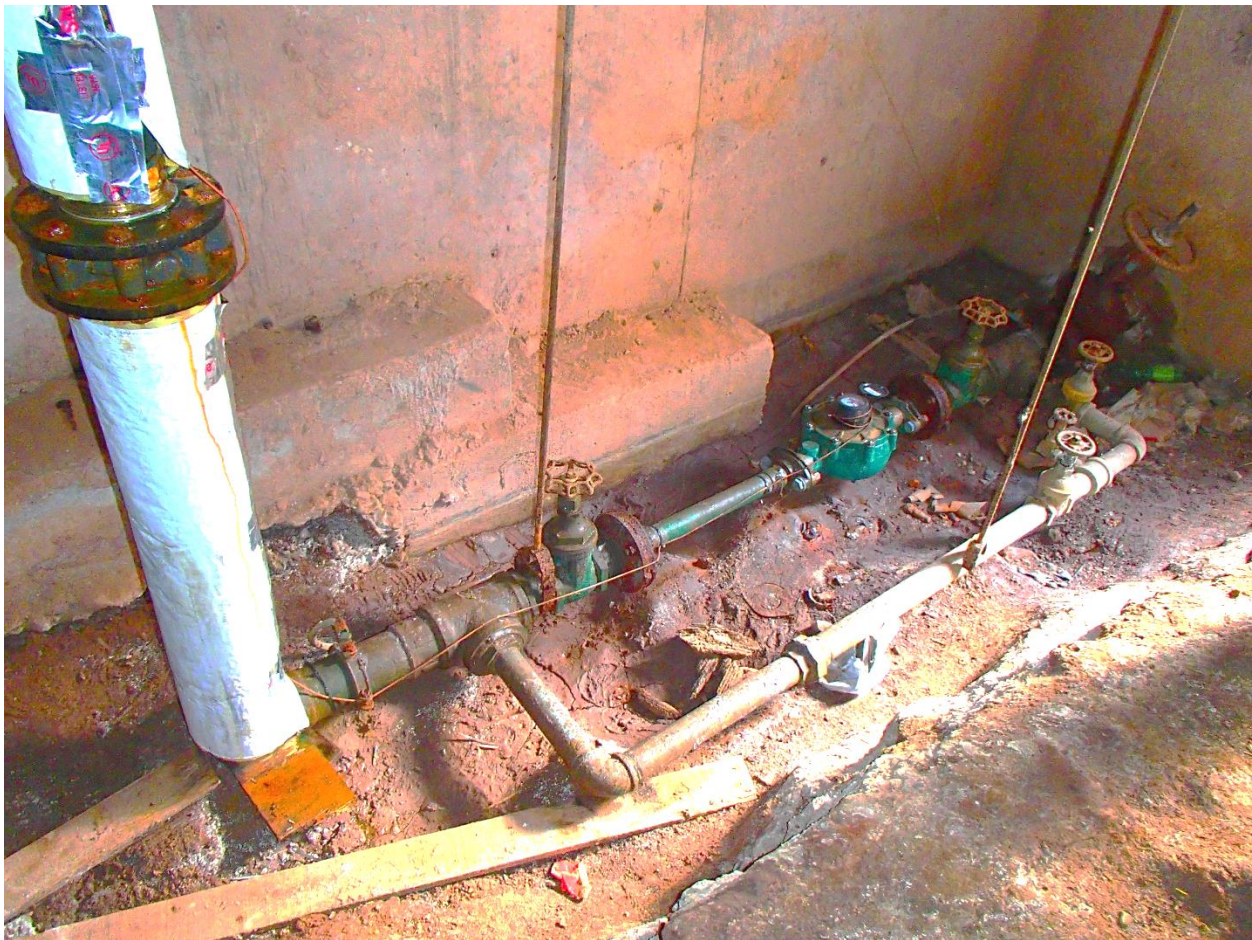
Water pressure is very good; 95 psi static. Water pressure greater than 80-psi is required to be reduced with a PRV valve. Water piping is copper tube with leaded solder joints. The water service is a public supply with a 3" main and meter entering a dirt crawl space under the gymnasium. The pipe is heat traced if there is a freeze up. There is no backflow preventer and the service is severely corroded due to the high moisture environment from the steam piping. It is recommended to remove and replace all water piping in the pipe tunnels.

- Replace ejector pump in boiler room, see attached cut sheet for pricing purposes
 - Replace severely corroded water piping in pipe tunnels, Copper tubing with soldered joints

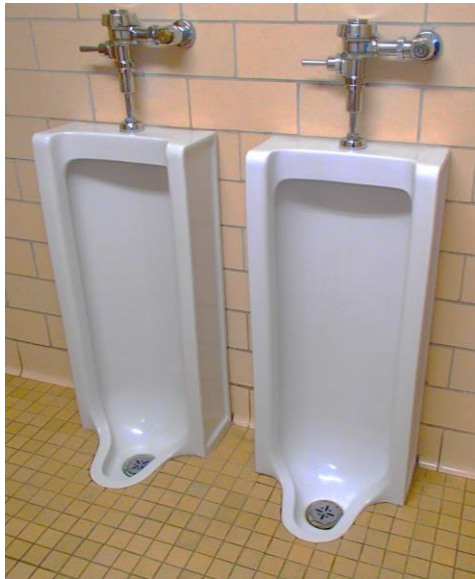
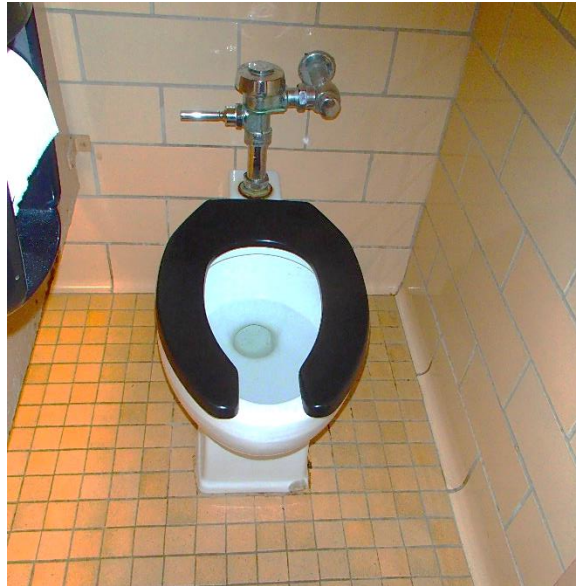
Plumbing fixtures are original except for the small renovated areas, as a result they are not ADA accessible, not energy efficient, not NSF and made with lead parts. It is recommended to remove and replace all the plumbing fixtures with new.

- Replace all plumbing fixtures with new, Kohler fixtures or equal with manual flush valves
 - Provide new ADA fixtures where required, Kohler fixtures with manual flush valves

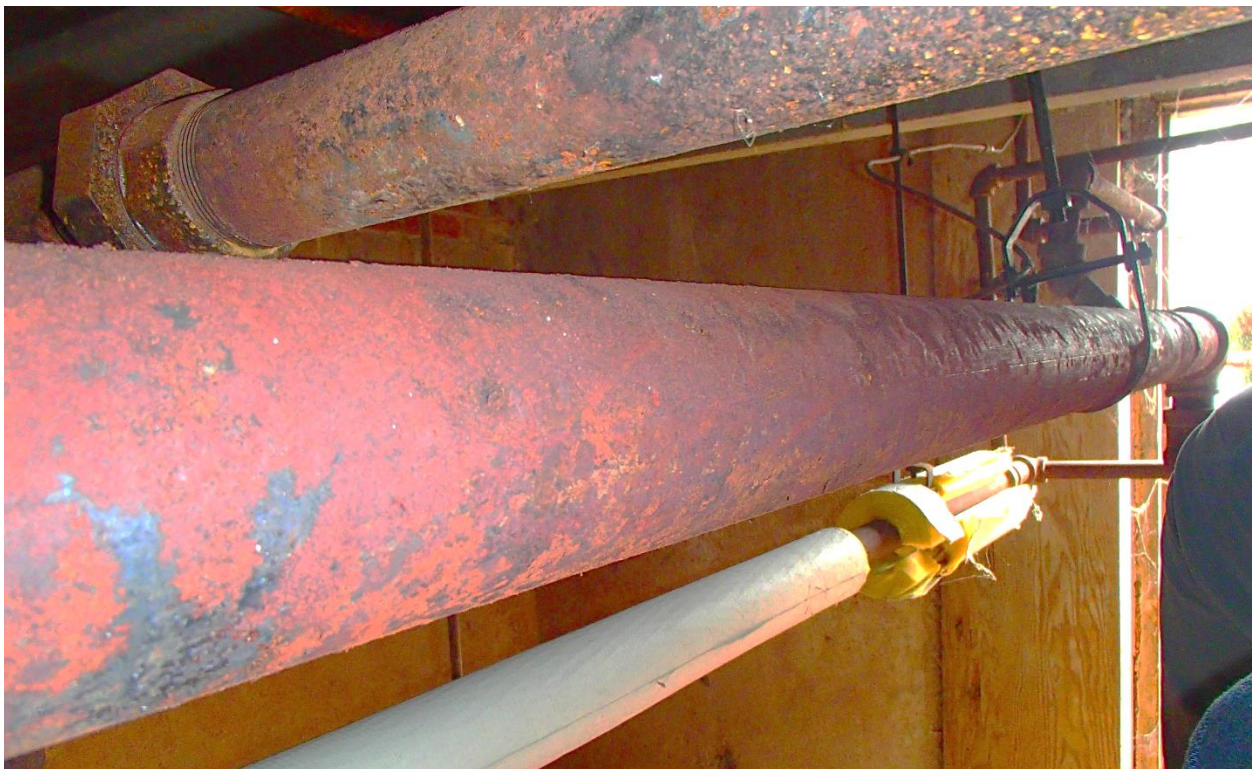
Sanitary sewer exits the rear of the building to a site sewer system. The majority of the piping is original, s cast iron and up to 66 years old and past its life expectancy. The piping has had a major failure recently in the pipe tunnels which incurred a replacement and cleanup cost of \$100,000. The steam piping and high moisture in the tunnels is causing severe corrosion due to the environment. It is recommended to remove and replace all the sanitary, waste and vent piping.

- Plumbing
 - Re-use existing sanitary main from building
 - Re-use existing domestic water service to building
 - Replace all existing sanitary piping in building with new except Transition Academy and Lower Level Reno Areas, PVC schedule 40 piping. Sanitary main in pipe tunnel was recently replaced and will remain.

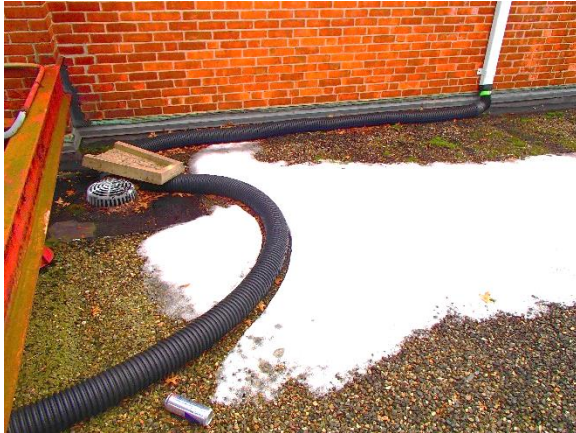
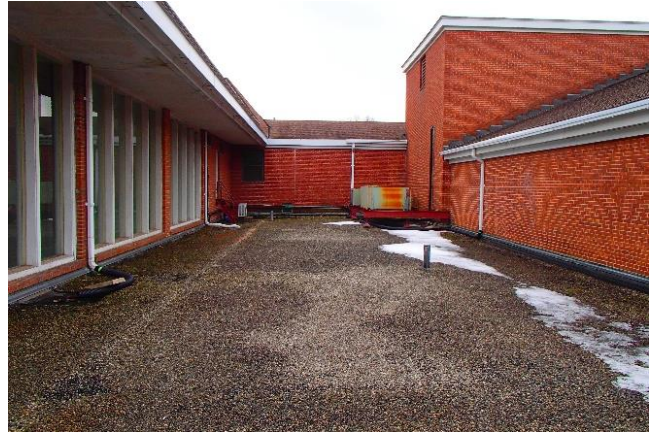
Roof drains were minimal as the majority of the roof is pitched to exterior gutters and downspouts. The flat areas have roof drains but the roofing membrane is severely deteriorated that the rain water does not readily flow to the roof drains and ponding occurs. There is no secondary drainage system as required by current code. If the primary system gets clogged or fails, a roof failure could occur. It is recommended that these areas be removed and replaced and brought up to current code.

- Majority of roof drains are exterior architectural gutters and downspouts
 - Replace and re-pipe roof drains for minimal flat areas, PVC schedule 40 piping

- Provide new overflow drains for minimal flat areas, Froet bifunctional type
 - Existing water heaters are newer to remain
 - Replace ground water pump in tunnel near boiler room, see attached cut sheet for pricing purposes

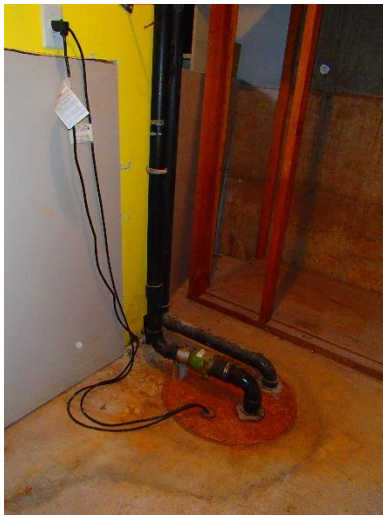
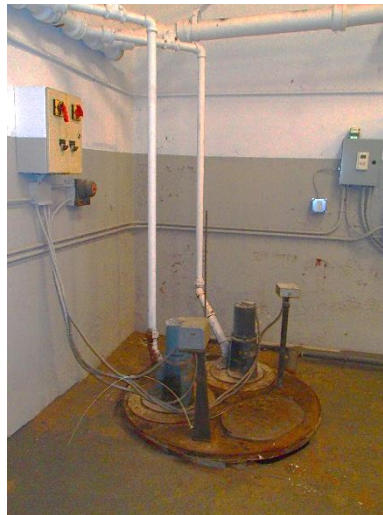
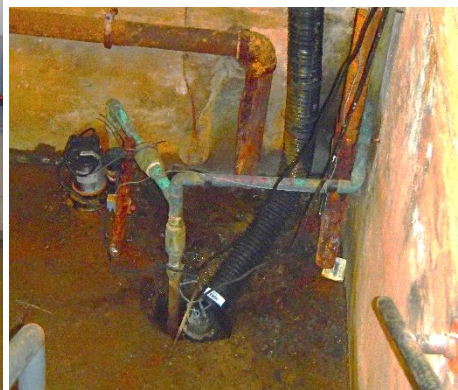
Sump pumps are located in pipe tunnels and basement areas. Some of these pumps are original to the building, well past their life expectancy and should be replaced.

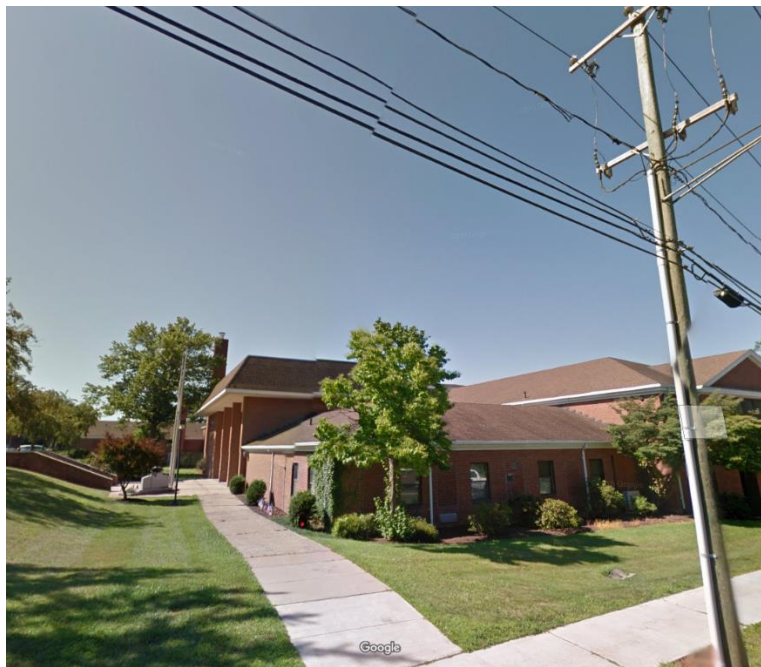
Electrical Service Pole

The existing electrical service to the building is routed via an overhead high voltage pole line beginning along Cedar Street, continuing around the east side of the building and eventually in to a transformer vault in the building. From the transformer, the secondary (service) conductors route through a wall into the back of the existing main electrical service switchboard that serves the whole building. The overhead lines and vault transformer are owned by the utility company. In current times, the utility company does not allow transformer vaults – all new transformers of this size are required to be located outside the building on a pad. Transformer vaults present more risk of fire damage to the building as compared to a pad mounted transformer.

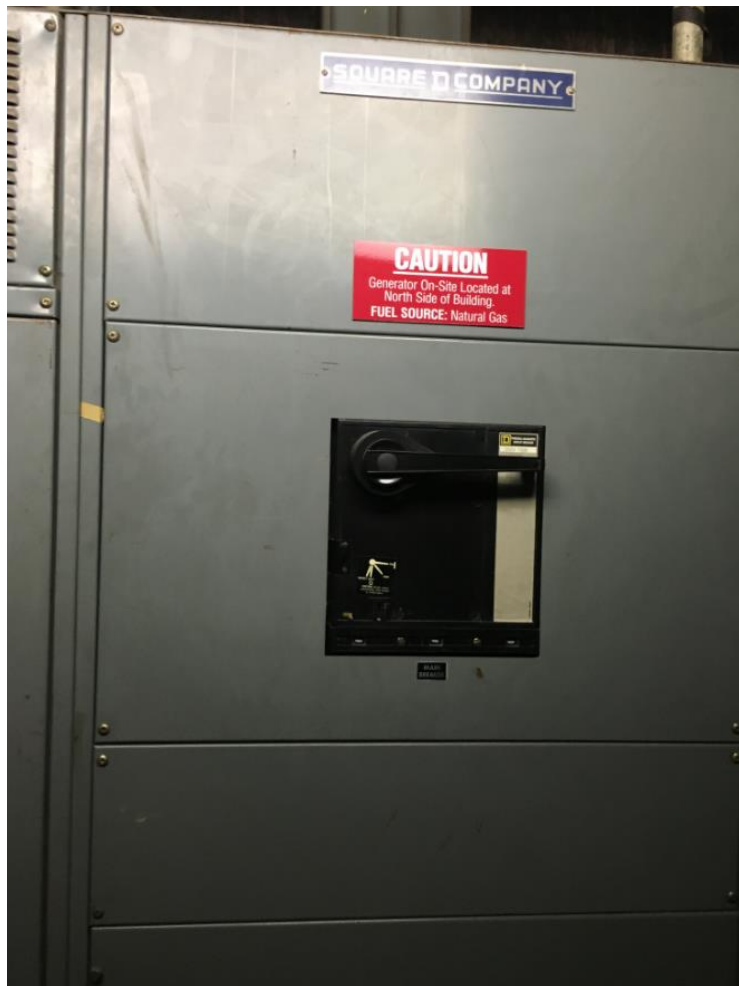
Existing Main Service Breaker

The main switchboard (1600A, 208Y/120V) is over 40 years old, contains original circuit breakers and is in need of replacement due to age and reliability. Older electrical equipment may not trip breakers when needed, causing fire hazard concerns. Modern switchboards contain more reliable digital trip circuit breaker, do not require fuse replacement after faults, and have readily available replacement parts. It is recommended that the electrical switchboard be replaced with modern digital trip circuit breakers, ground fault protection and surge suppression for reliability and safety of the electrical system.

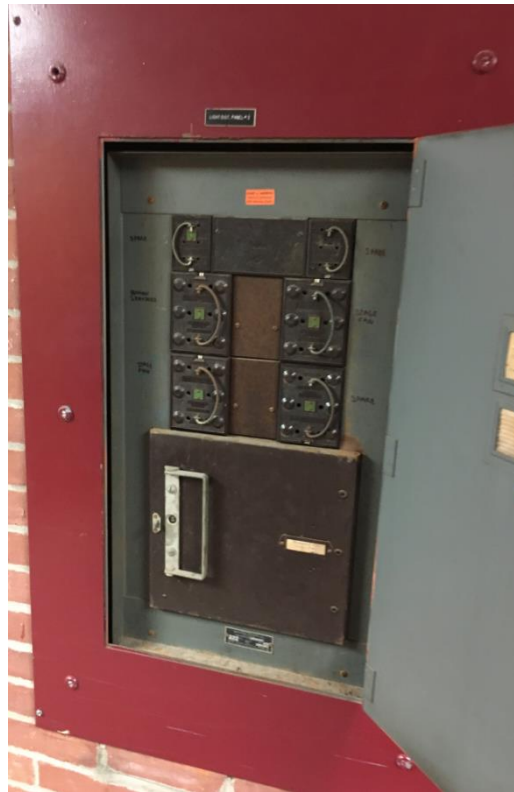
Example of Old Electrical Panel

From the switchboard, power is distributed through a multitude of panelboards located throughout the building. The majority of this equipment is also over 40 years old and should be replaced due to age and reliability. Many panels also contain fuses, and are likely over 60 years old. Many existing panelboards are also full, which decreases ease of adding new electrical circuits as they are needed. DTC was not able to observe wiring methods within the walls and above ceilings, but due to age it is assumed cloth wiring is present in the building, which presents fire safety concerns.

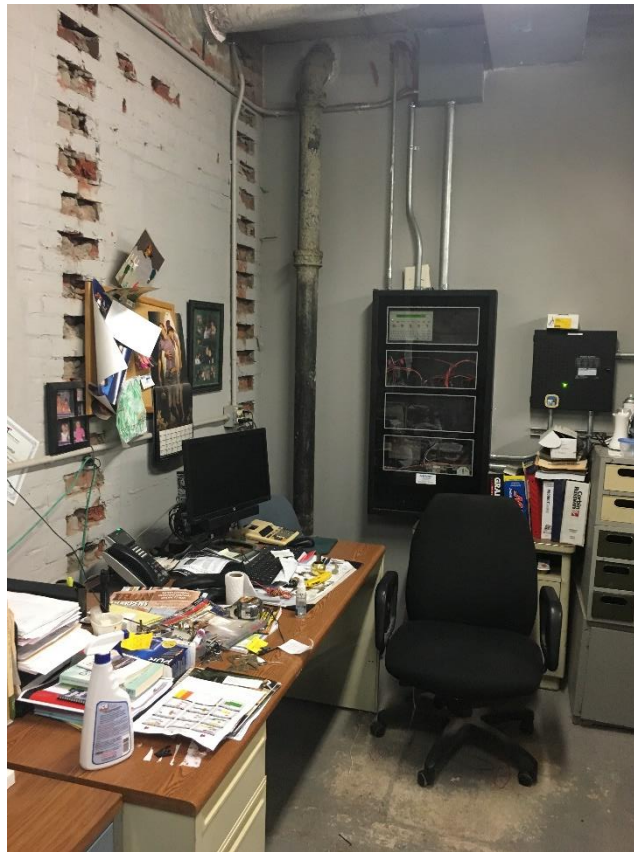
Existing Fire Alarm Control Panel

The fire alarm control panel is manufactured by Notifier, is addressable, expandable and is not in immediate need of replacement. Many of the fire alarm devices throughout the building appear to be non-addressable devices that should be upgraded to addressable for additional fire safety. The placement and quantity of fire alarm devices around the building do not meet code in many places. Many of the exterior doors do not have pull stations and many of the rooms do not have adequate audio/visual coverage per current NFPA requirements. Smoke detectors should be added to all electrical, IT and storage rooms. Some critical document storage areas do not have adequate smoke detection coverage, which is quite risky. Voice evacuation should be provided in all areas of assembly. As such, it is recommended that new addressable devices be provided throughout the building, and connected to the existing (Expandable) fire alarm control panel per current NFPA requirements. This will increase fire safety within the building, and will improve fire department response
